LAKE FRANKLIN PIERCE DAM

N.H. 00199

PHASE I INSPECTION REPORT
NATIONAL DAM INSPECTION PROGRAM

AUGUST 1978

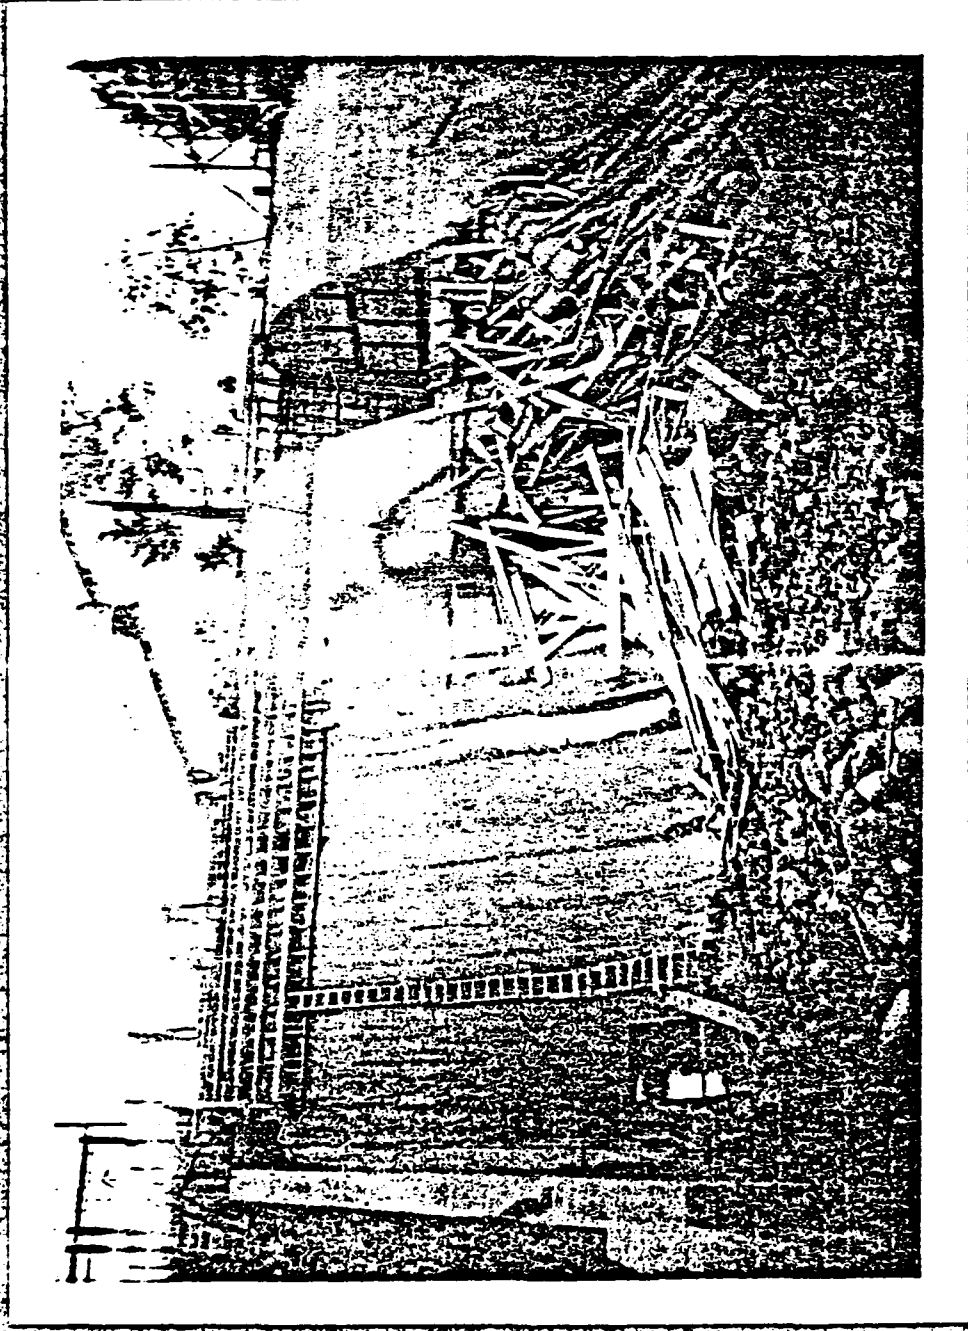
#193 View taken from same position as #191 showing south of #192
3:52 P. M. October 9, 1926.

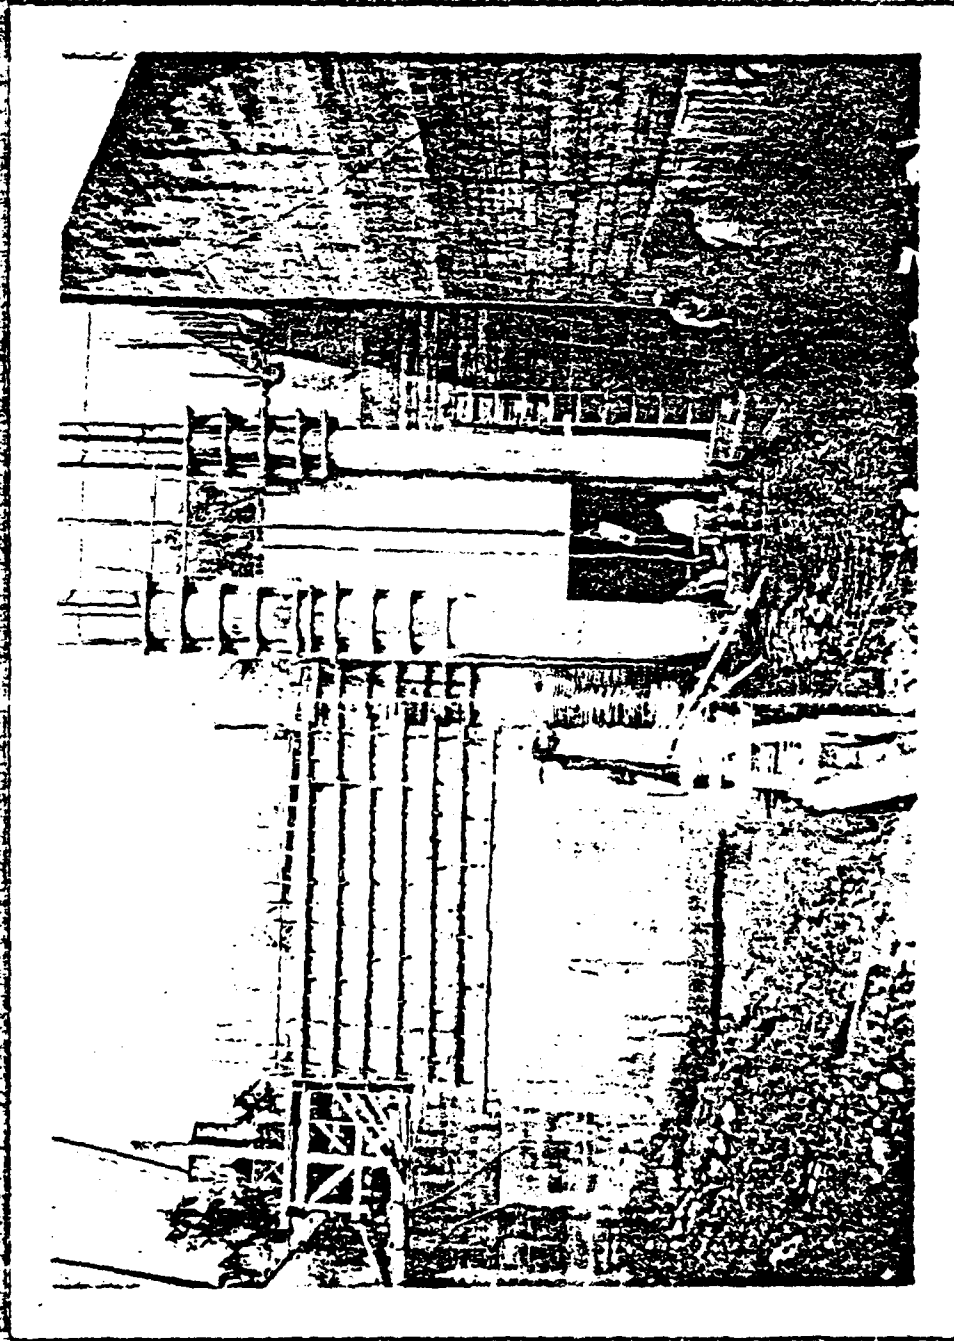
#172 View taken from a position at about CL 0-17, RL 0-100, showing intake and sluiceway 3:00 P.M. September 24, 1926.

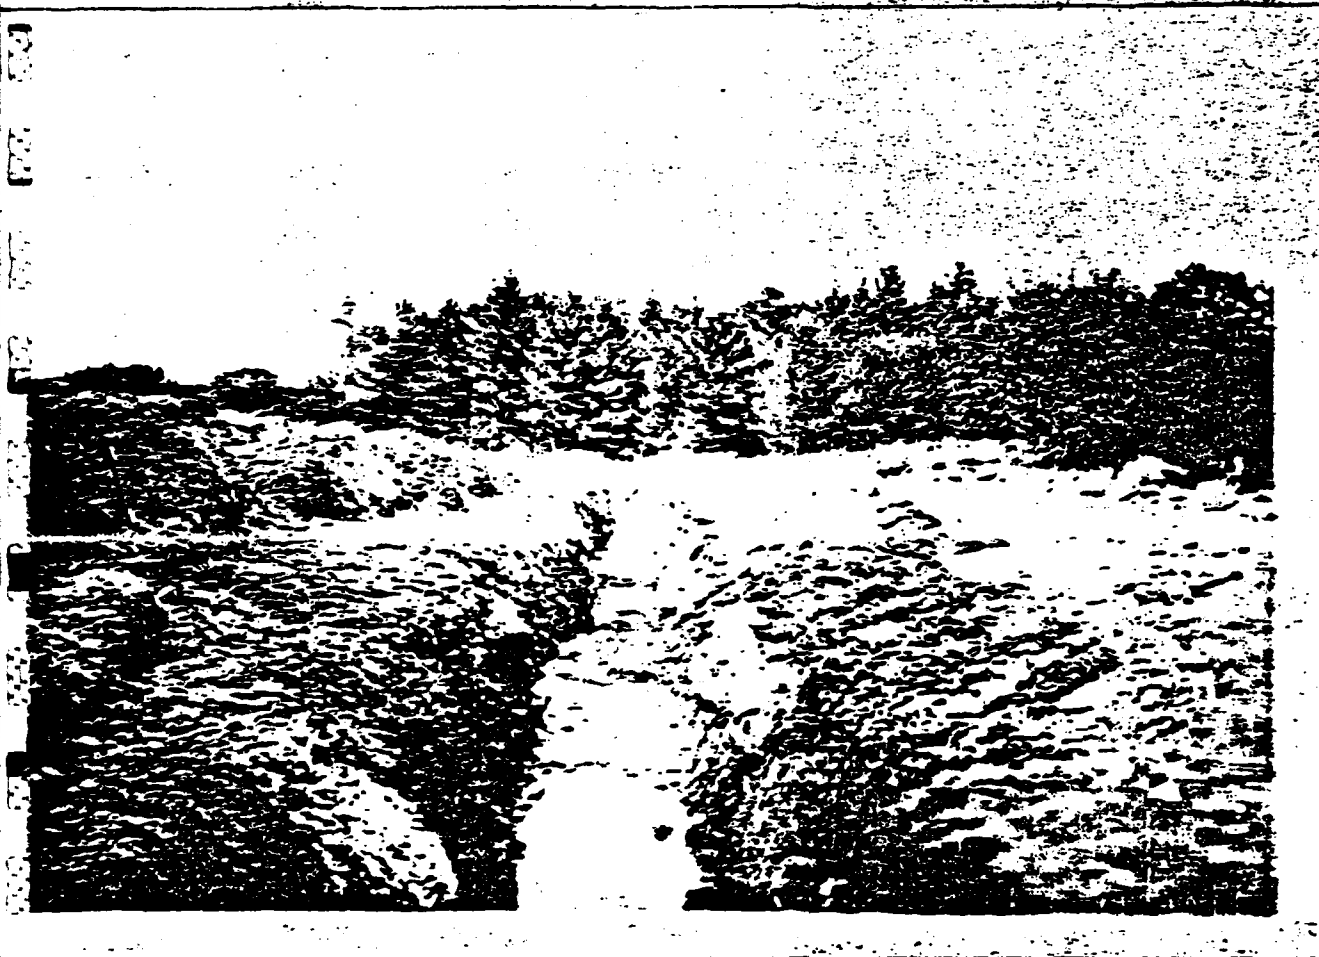
121. Jackman Development. View taken of north dike from old road looking north. 12:30 P.M., July 1, 1926.
